# TOURLE STREET BRIDGE UPGRADE

FREYSSIMIX JET GROUT CUT-OFF BARRIER

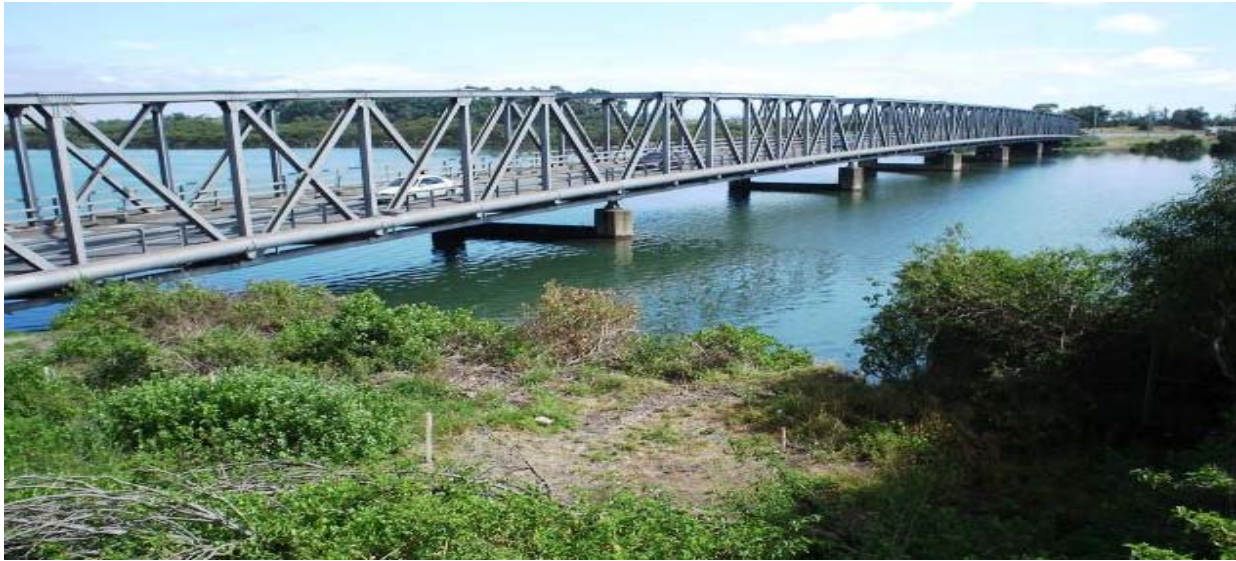
The main benefit of this solution was the minimal disturbance to the in-situ contaminated and un-contaminated soils during the construction process. Two rows of contiguous jet grouted piles were installed adjacent to each other, thus forming a continuous barrier in the desired location. The columns were installed several meters below existing ground level, a cutoff was formed in a layer of natural clay and the columns finished at the same RL as the mean high water level. This allowed both tidal waters and natural ground water flow into the river to pass over the wall and hence not artificially raise groundwater levels in the local area. Whilst doing this the barrier also provided the desired cutoff to prevent the flow of contaminants into the river from the contaminated soils below the water table.
